# Manhole Inspection Summary

Manhole # S39E\_\_018MH

**Location** Address: **1027 e.baltimore st**

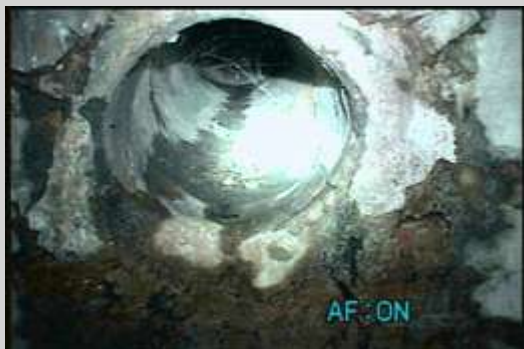
3 O'Clock Inflow

Pipe Height: 0 (in.) Direct

Pipe Material: Clay ☐ Pipe Lined

Invert Depth: 9.30 (ft.) Flow Characteristics: None

Deposits: ☒ None ☐ Mud ☐ Sludge ☐ Debris ☐ Grease

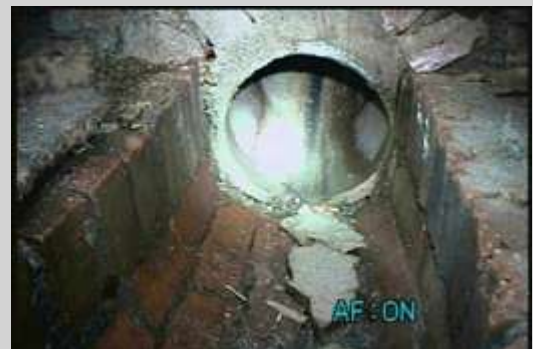
Drop In @ 3 O'Clock

Drop: Outside Direct

Drop Condition: Open
